Service Bulletin

December 18, 2020 Version 1

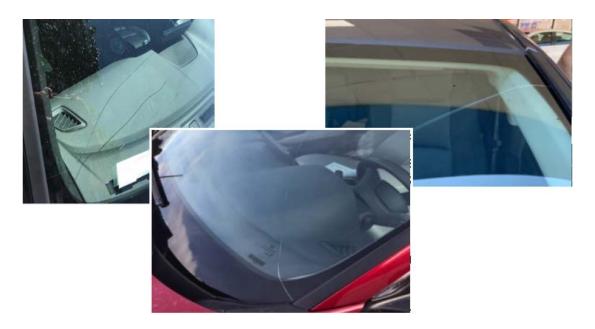
Make sure the crack is similar to the examples shown in the photos. If the windshield is cracked from debris or other objects, or cracked in another location, this service bulletin does not apply.

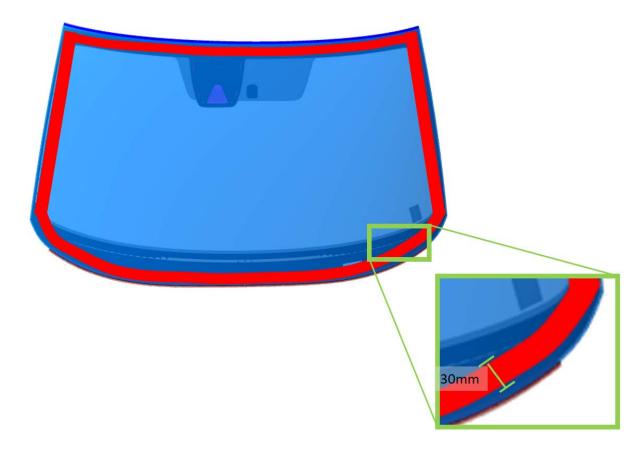
The area up to 30 mm from the outer edge of the windshield is susceptible to cracking.
